RAILROAD AVENUE BRIDGE
(Church Street Bridge)
Spanning Mispillion River on Church Street
Milford
Sussex County
Delaware

HAER No. DE-36

RAILROAD AVENUE BRIDGE
(CHURCH STREET BRIDGE)

DESCRIPTION

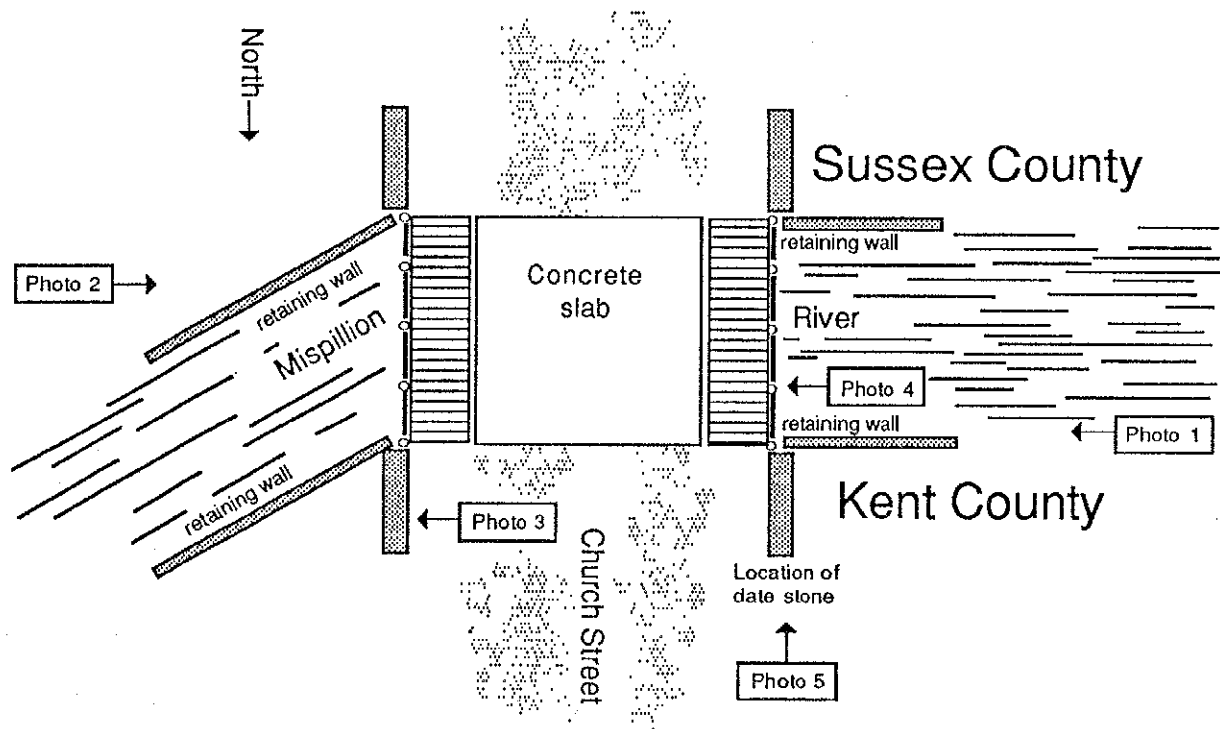
SKETCH PLAN

(Not to Scale)

Railroad Avenue Bridge spans the Mispillion River between Kent and Sussex counties, Delaware, in the city of Milford. Between stone abutments, the span is 36 feet. In midstream is a concrete support that appears to be a later addition.

The concrete roadway, 34 feet 10.5 inches wide, is supported by steel beam stringers encased in concrete, spaced 36 inches apart on centers. The deck over these beams is concrete, eight inches thick. Wooden walkway decks on both sides of the bridge are supported by steel I-beams. Other steel I-beams have been inserted transversely under the bridge at its center, probably at the time the concrete support was inserted.

Bridge abutments consist of stone masonry resting on oak pilings. The midstream concrete supporting pier also is supported by pilings. Iron handrails along both sides are supported by cast-iron posts and connected by strap-iron lattices.
